The Case of the Flying Varistor

Scott Little,^{*} Harold Puthoff^{*} and Colm Kelleher^{**}

Introduction

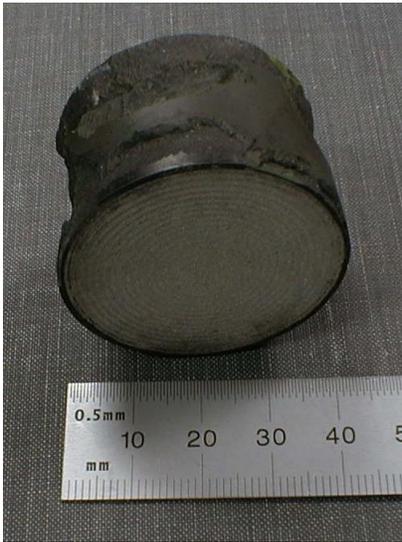
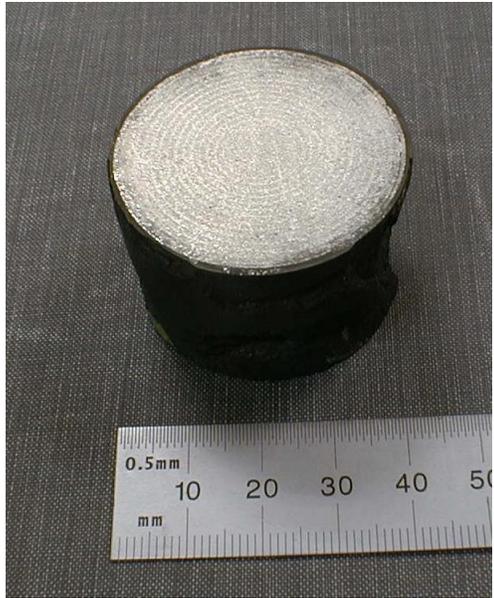
NIDS was contacted by the family and informed that the object was anomalous and possibly extraterrestrial since it had fallen from the sky. NIDS received the object on February 24, 2001. By visual inspection, it was obvious that the object was manufactured and was not a meteor.

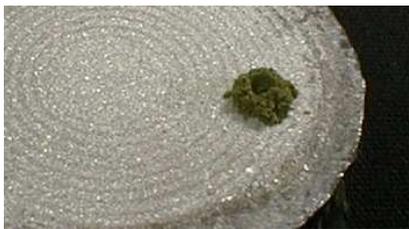
Instead of curly metallic shavings, a green powder came out of the hole! By looking in the drilled hole it was now clear that the metallic faces on the object were just thin coatings. The object was apparently composed of a dark greenish material throughout.

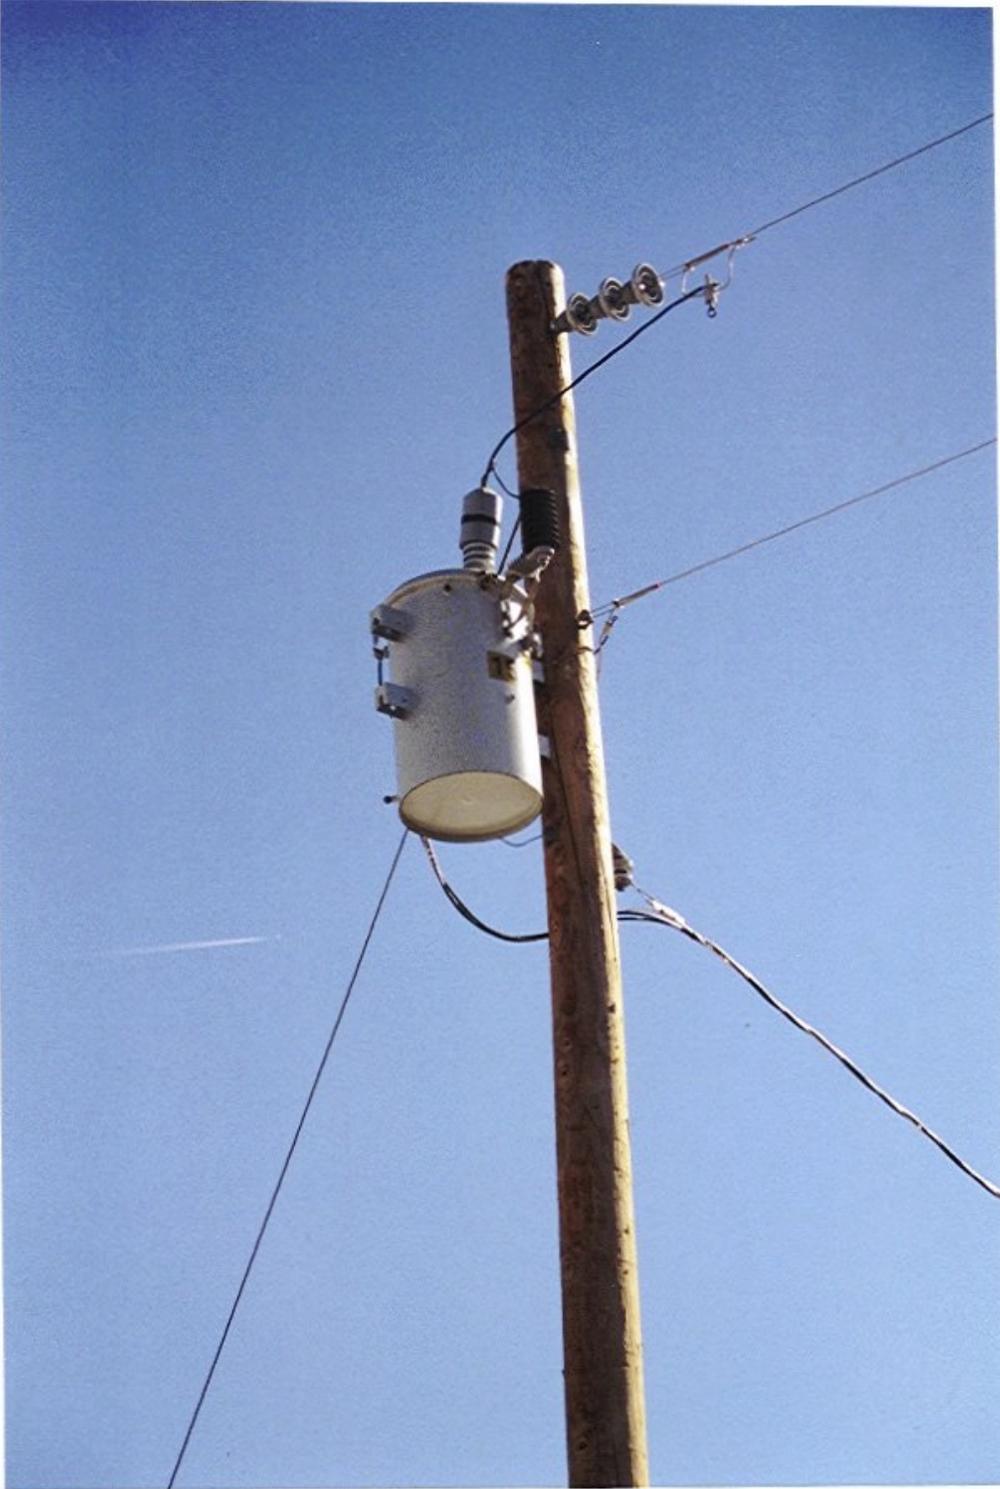
Next, NIDS sent an investigator to the home of the man who had witnessed the flying varistor. The investigator confirmed that indeed there was a power pole located on the man’s property about 100 feet from where the varistor had landed in July of 2000 (see photo below).

Therefore, the most parsimonious explanation is that the object is a varistor that had been launched from a pole 100 feet away and landed near the owner of the property in July 2000 during or following a lightning strike. It is even possible that the lightning strike occurred further down the line. The varistor would have been ejected after failure due to a power surge and would have been still warm when the witness retrieved it from the soil.
